# AUTOMATION POWER MODULES: TYPICAL FAILURE MODES AND HOW TO SOLVE THEM

## IGBT FAILURE ANALYSIS – FIRST AID FOR EMERGENCIES

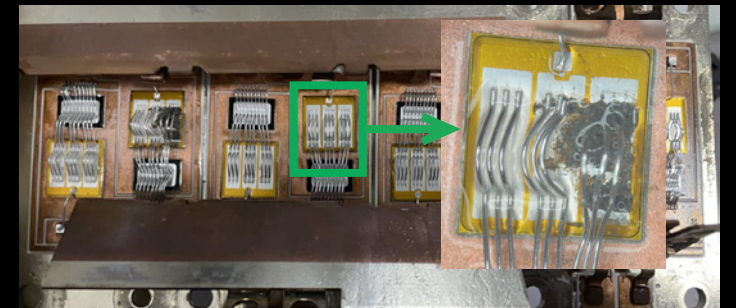
**Figure 1**  
Image of failed IGBT-die with molten top metallization

Opening up a failed IGBT-module often reveals one or several dies with black spots, which, under higher magnification are visible as molten layers of the chip's top side metallization. Generally, this is caused by either by current or voltage spikes, an explanation however too general to derive any further actions of how to prevent it from repeating. Naturally, the finger of blame is often pointed at the manufacturer and parts returned for further analysis.

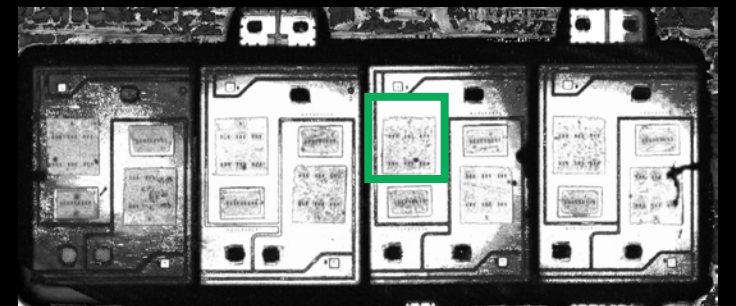
**Figure 2**  
Ultrasound analysis of solder connection between die and DBC

The next logical step is to check for manufacturing errors, especially by analysing the solder layers as voids here often directly lead to either bond lift-offs or in severe cases complete melting of the chip metallization. In this particular case however, Fig. 2 and 3 show no abnormalities in the solder connection.

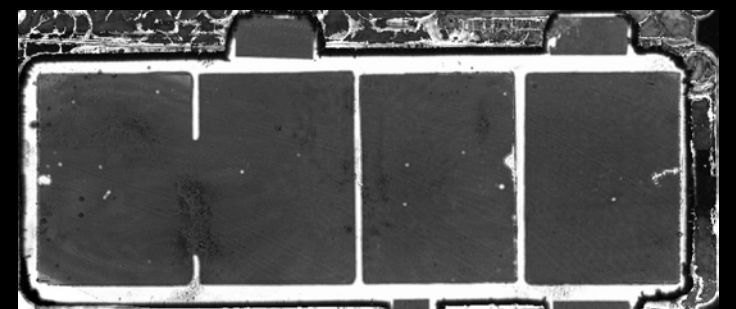
**Figure 3**  
Ultrasound analysis of solder connection between DBC and baseplate

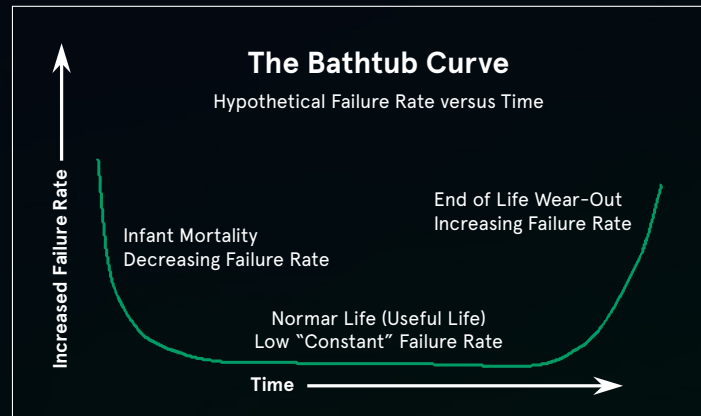
**Figure 4**  
Bathtub life cycle curve for technical applications,  
©www.weibull.com

To offer predictability and reliability in this part of the bath-tub curve (Fig. 4), module manufacturers perform process qualifications in the design phase of the module. These tests include mechanical stress, high temperature and humidity as well as power and thermal cycling assessments – often referred to as accelerated ageing.

It can happen that returned modules have failed right at the beginning of the application life cycle in the early stages of the bath-tub curve. Finding root-causes and potential fixes here is not easy and therefore, a systematic approach is recommended that should include the following considerations.

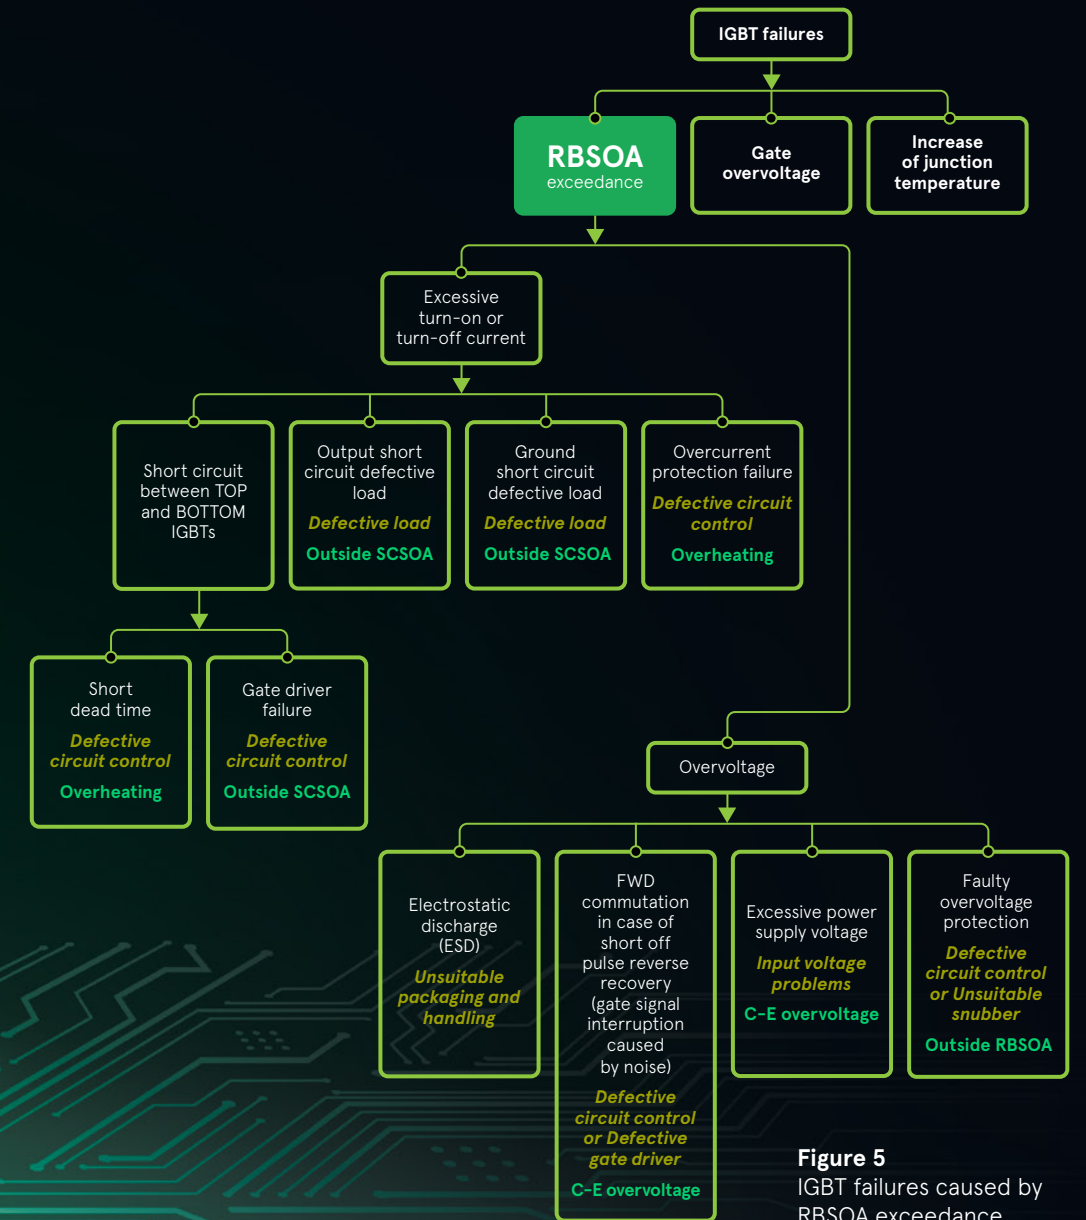
**Figure 5**  
IGBT failures caused by RBSOA exceedance

Looking at the IGBT, the first area to consider is the Reverse Bias Safe Operation Area (RBSOA) illustrated in Fig. 5, which is usually described as a range of  $V_{ce}$  and  $I_c$  under which the module can be operated without concern. The corresponding graph is typically described in the module data sheet.

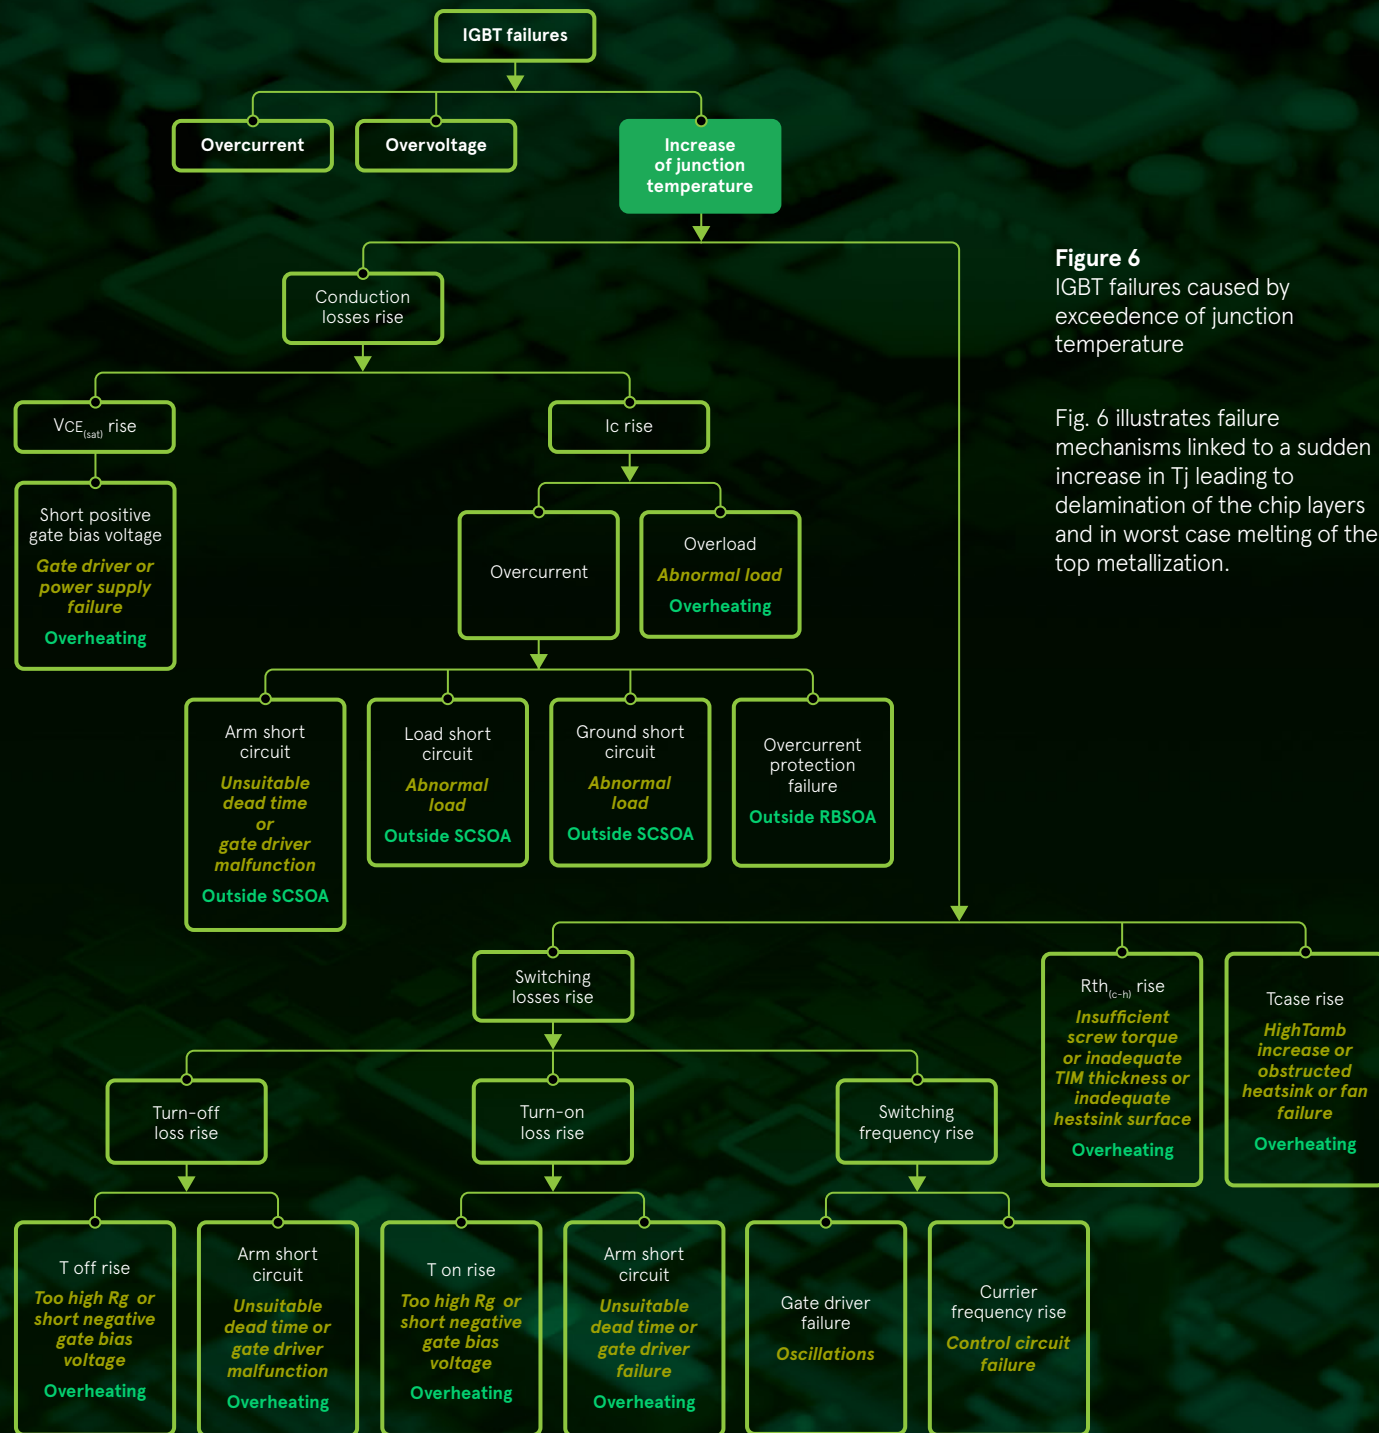
**Figure 6**  
IGBT failures caused by exceedence of junction temperature

Fig. 6 illustrates failure mechanisms linked to a sudden increase in Tj leading to delamination of the chip layers and in worst case melting of the top metallization.

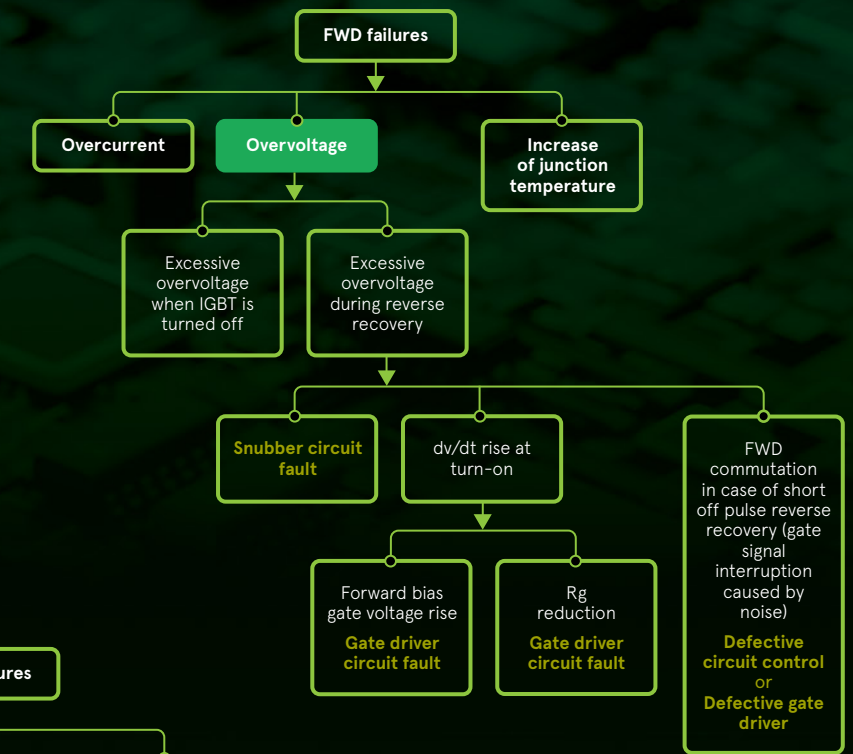
**Figure 7**  
Failures caused by overvoltage at the free-wheeling diode (FWD)

The other main area to consider in the IGBT-module is the FWD diode chip, which is deployed as a standard together with every IGBT die. Fig. 7 highlights again overvoltage events as a main source of these events, caused often by defective or unsuitable gate driver or control circuitry.

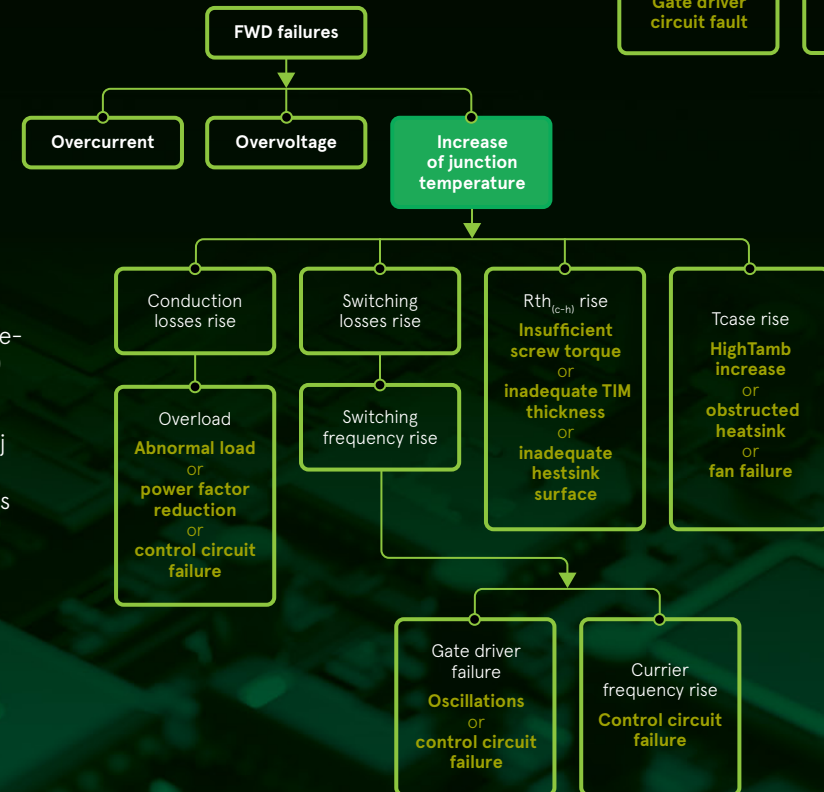
**Figure 8**  
Failures caused by overvoltage at the free-wheeling diode (FWD)

Sudden increase in Tj on the FWD can be a final area to look at as highlighted in Fig. 8.
